# **Navajo Abandoned Uranium Mine**

## **Site Screen Report**

### **Mesa II 1/2, Mine 4 AUM Site**

**March 2010**

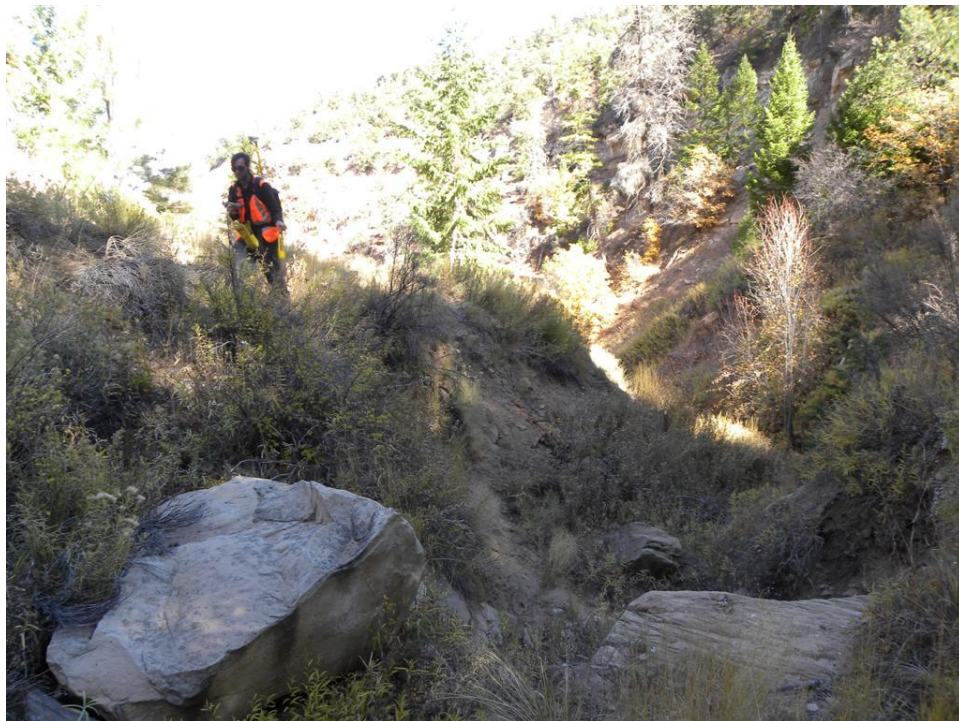
Various mining debris was present at the site. The drainage running through the site had some running water, and starts at the adit in the adjacent site, Mesa III Mine. Drainage was followed until the slope became impassible.

Photo 1. Mine site drainage

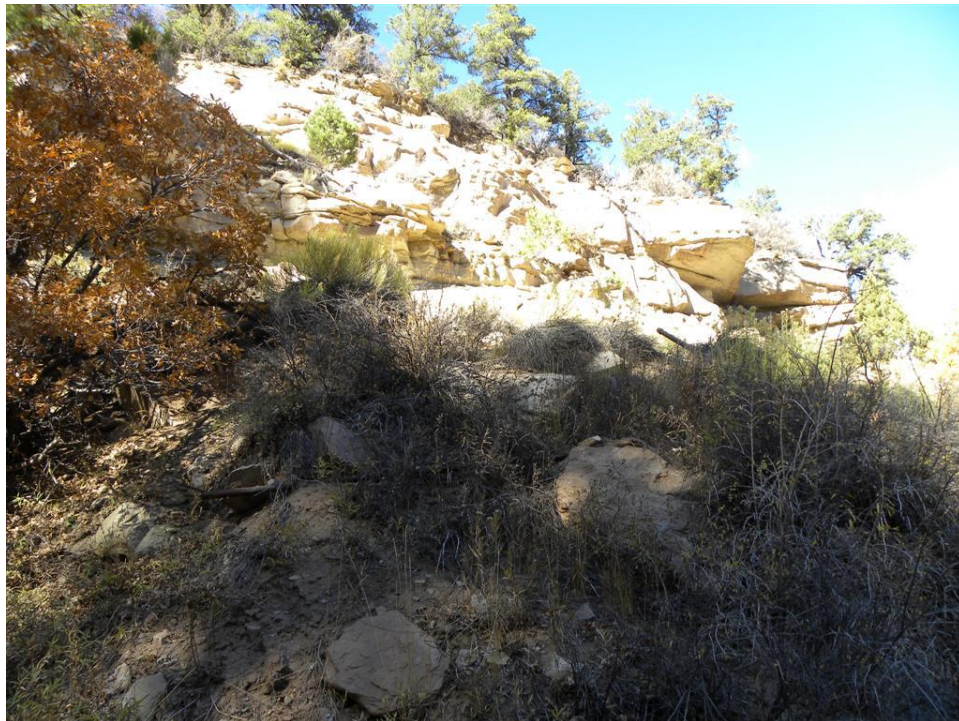
Photo 2. Waste rock

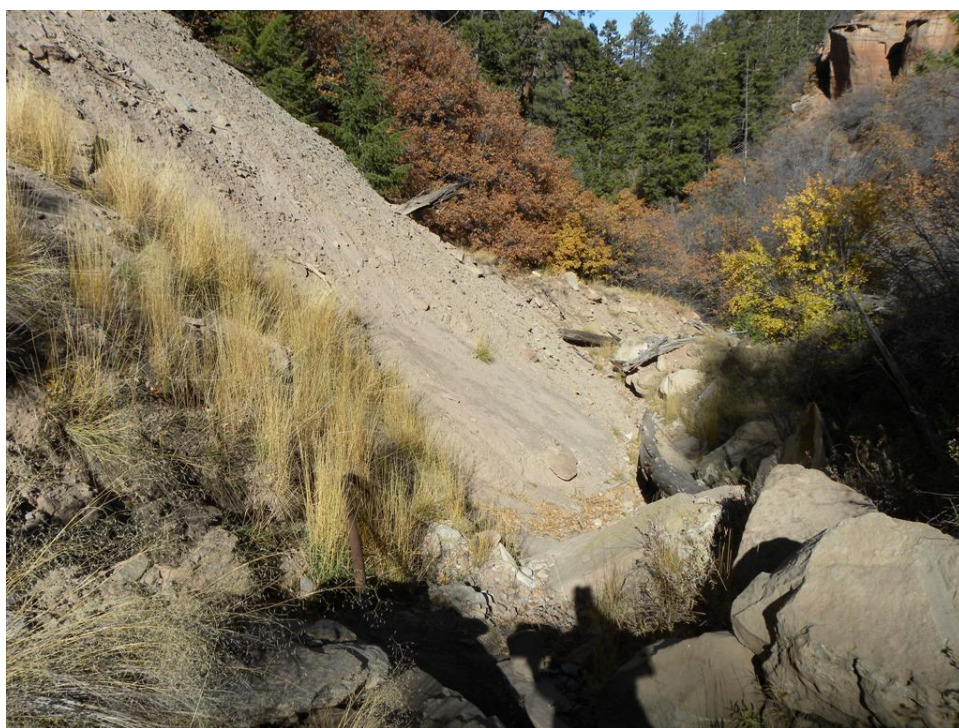
Debris piles throughout the south end of the site: 150' x 50'; 75' x 75'; 30' x 60', with a total estimated volume of 2,764 yd<sup>3</sup>

Photo 4. Waste pile

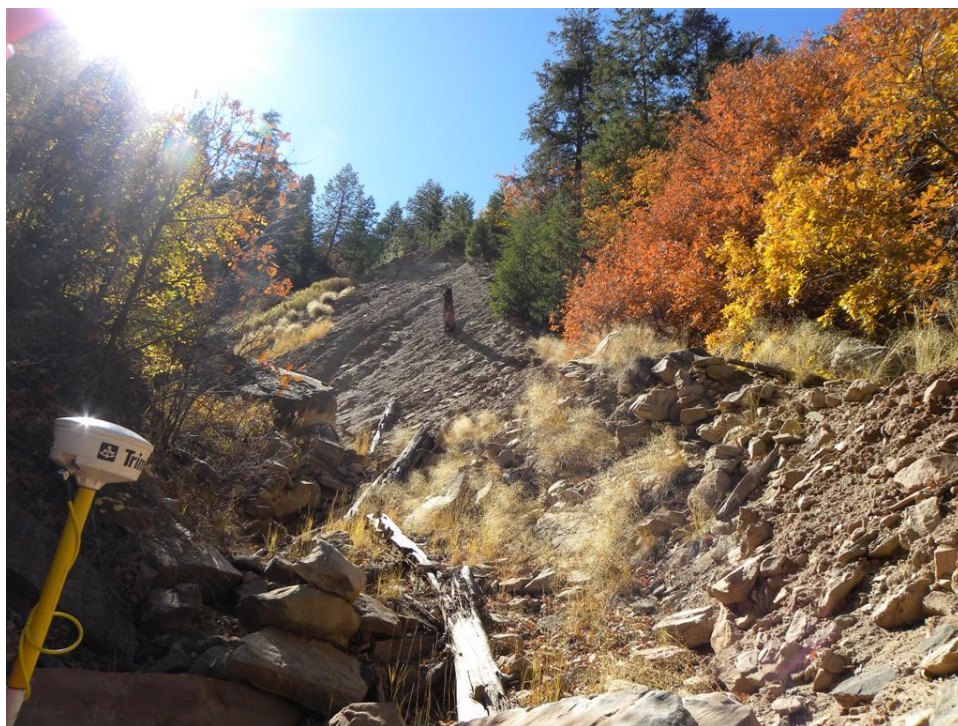
Photo 5. Drainage

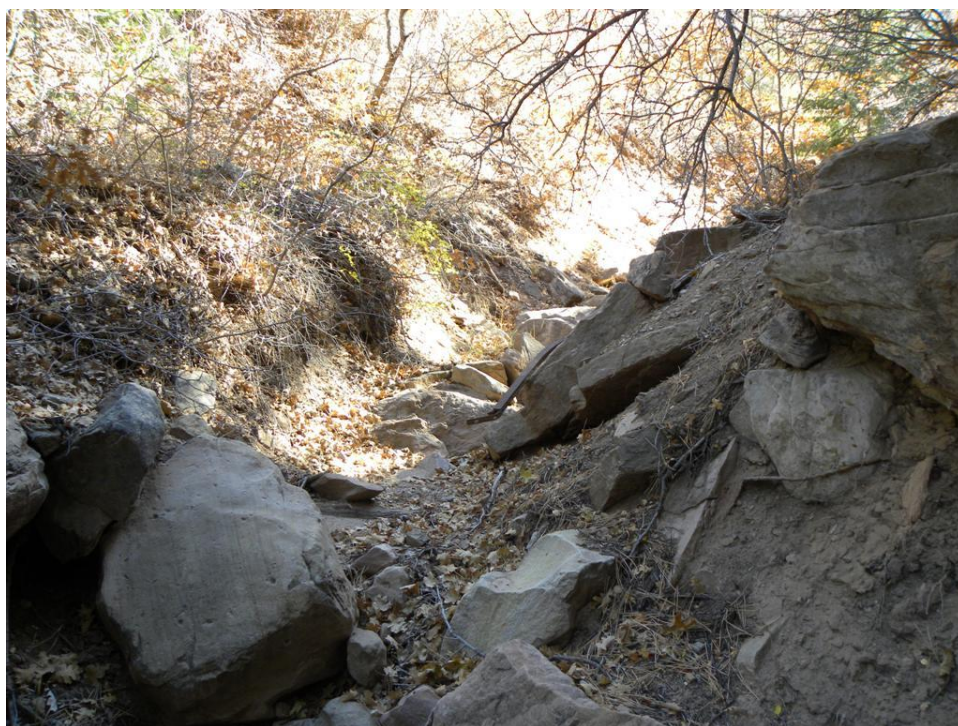
Photo 6. Drainage off site

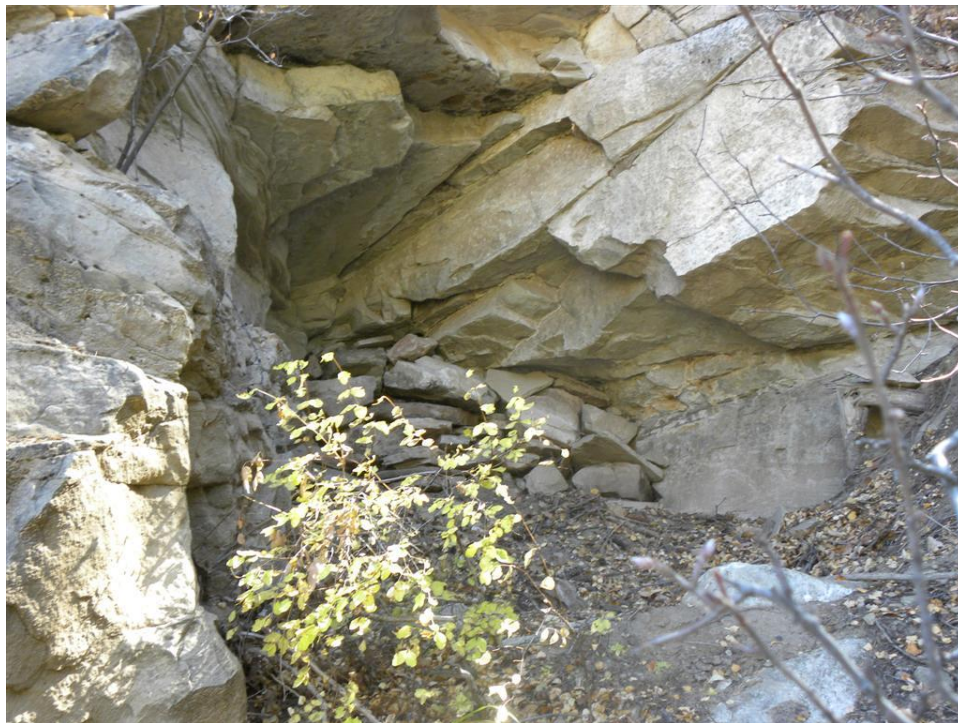
Stone sealed adit

Photo 7. Sealed adit

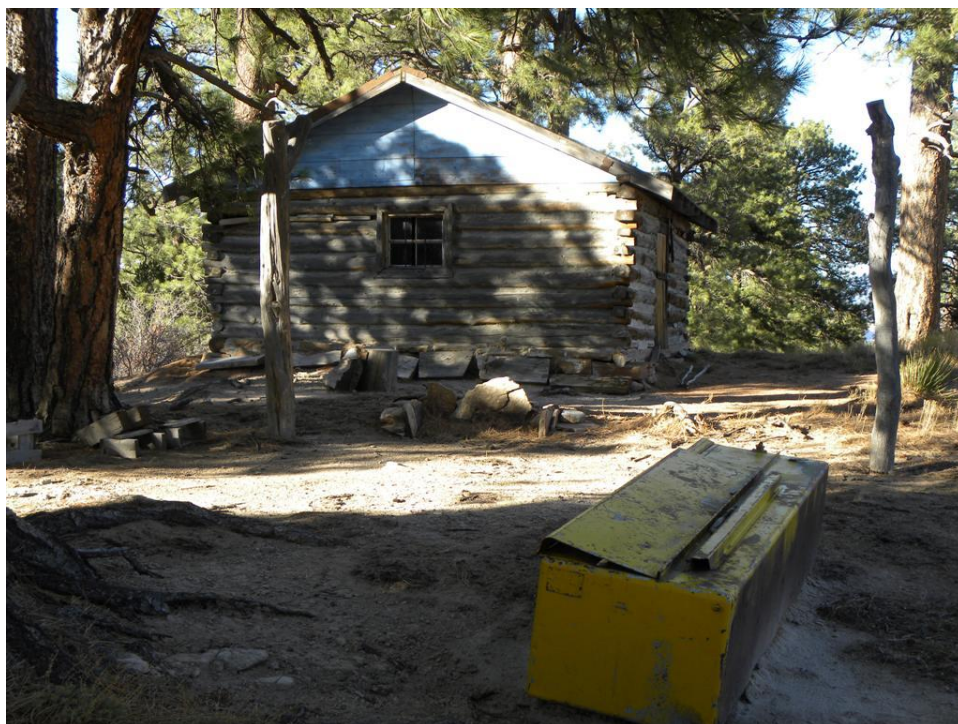
**200 feet to 0.25 mile:** An unoccupied house was located at the top of the mesa, approximately 0.25 miles west of the site

All gamma radiation measurements collected in the vicinity of the house were less than 11,000 cpm

Photo 8. House 0.25 miles west of site
